Reference Manual

# Troubleshooting an Enphase Microinverter System

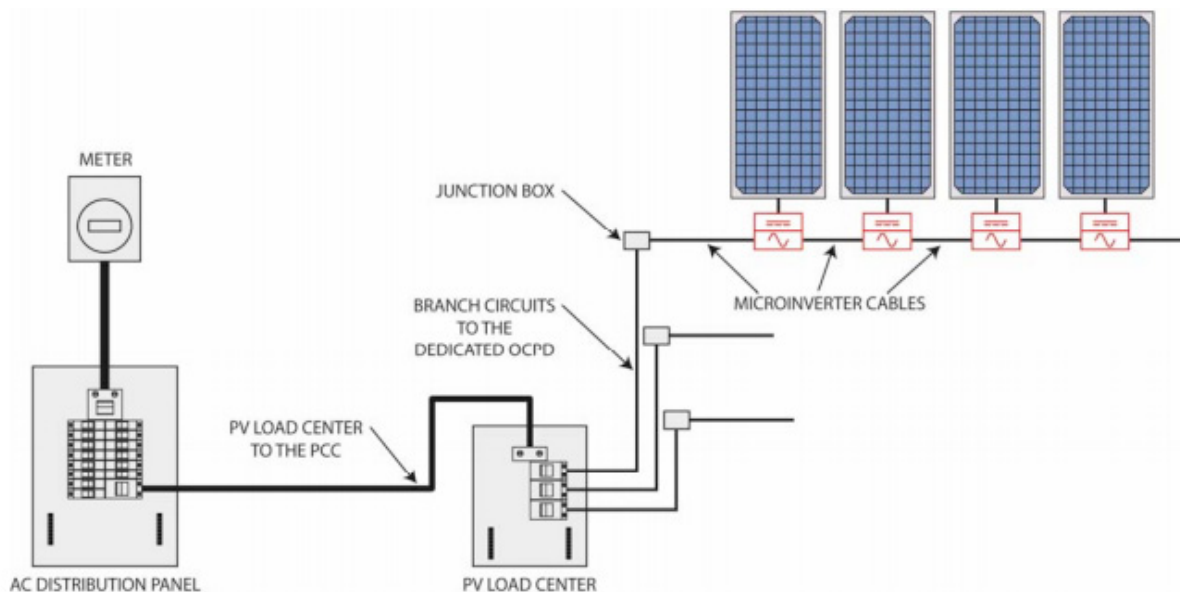
1. Measure voltages for L-L and L-N for all phase-conductors at the service entrance (PCC), at each Enphase branch circuit breaker, at each Enphase branch circuit junction box, at each Enphase branch circuit AC pigtail (if used in this installation), and at the last micro-inverter of each Enphase branch circuit.

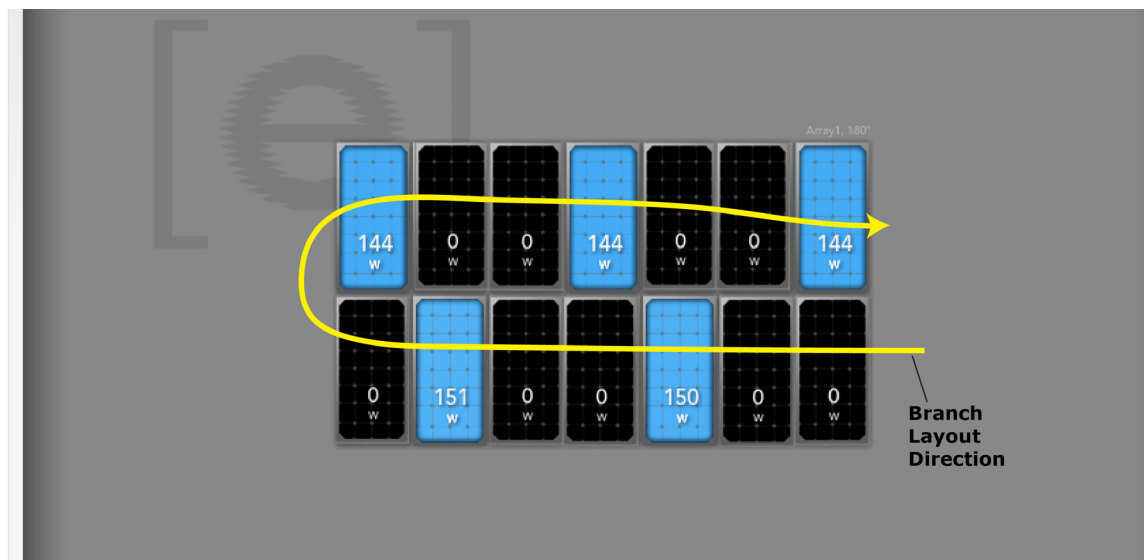
1. If the condition alternates among microinverters, incorrect cabling may be in use. The following Enlighten snapshot shows the result of using 208 Volt cabling at a site with 240 Volt service. Notice that only every third unit is productive.

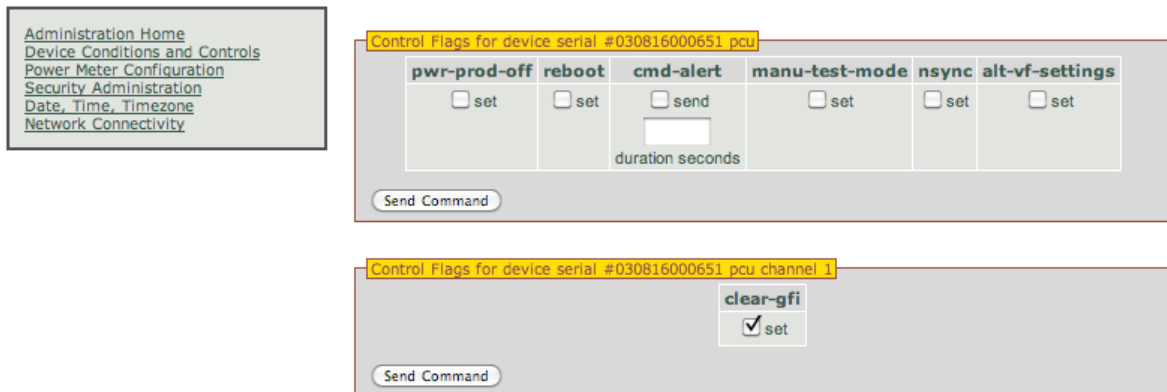
7. Click "Administration", and when prompted for credentials, enter the username as **admin** and the password as **admin**.
8. From the Admin menu, choose Device Conditions and Controls.
9. Click on the serial number of the unit exhibiting the GFI condition.  
**NOTE:** Do not click or select the box under the column labeled "Select".
10. In the clear-gfi box, select "set".
11. Click "send command".

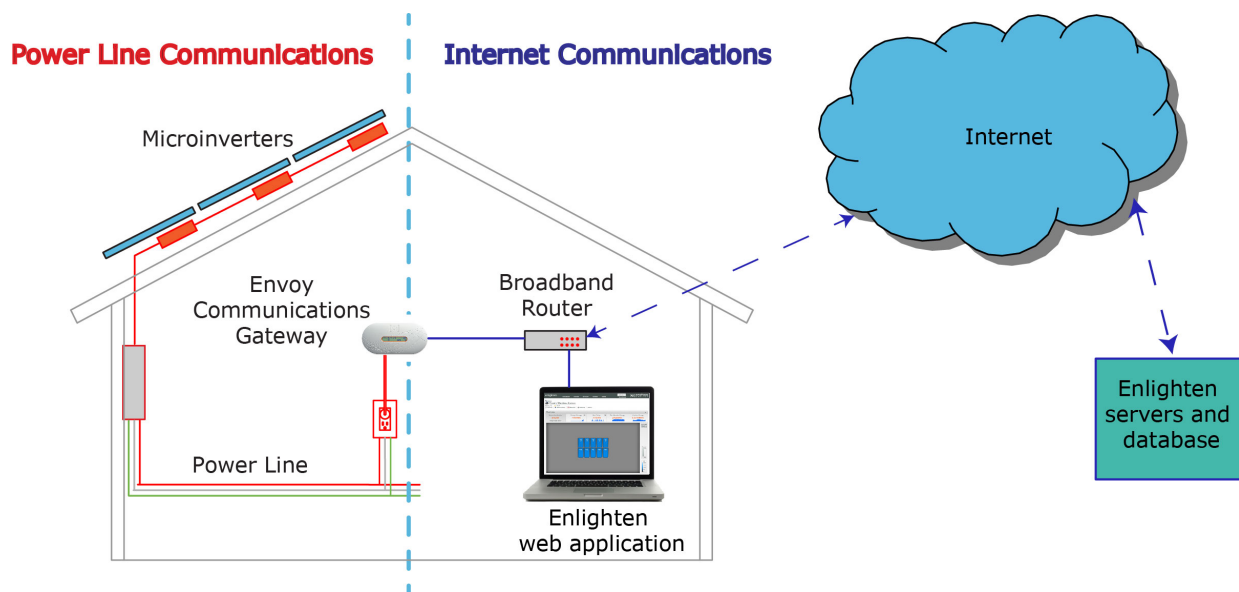
Power line communication between the Envoy and the microinverters is completely separate from the Envoy Internet communication. That is what makes the Envoy a "gateway device". One side of the Envoy communicates with the microinverters via the power lines. The other side of the Envoy communicates with the Internet using a standard Ethernet/network cable plugged into your broadband router.

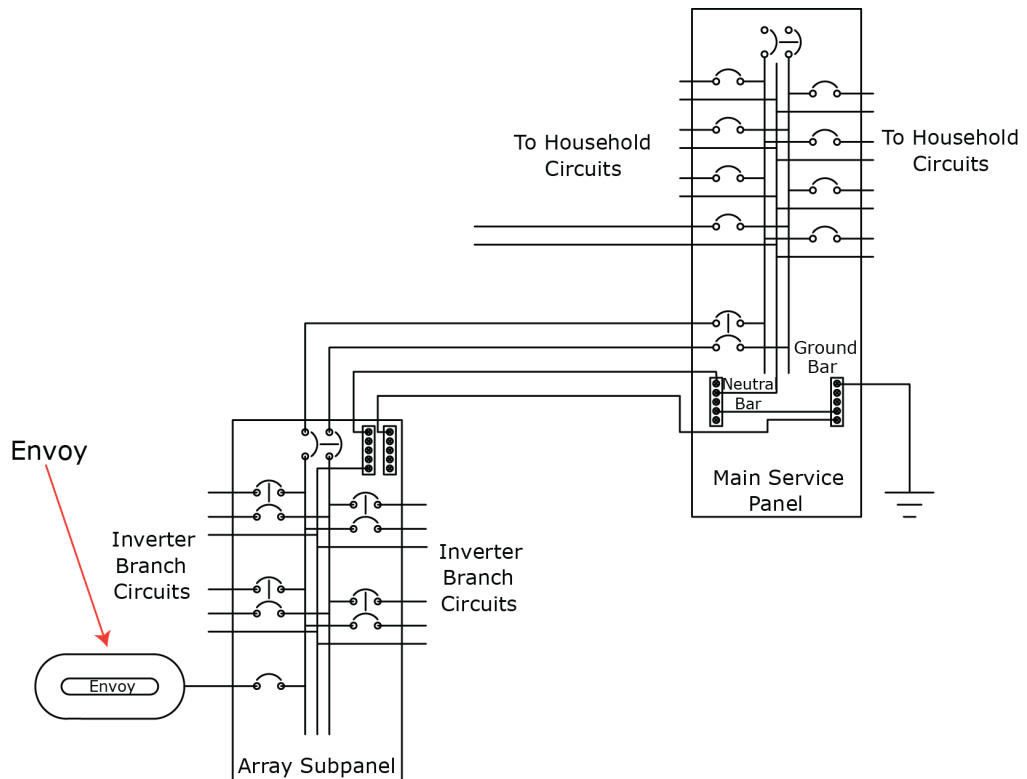
If the primary load-center is full, and doesn't have additional capacity to add circuit breakers for solar, the solar installer will sometimes add a subpanel, which is just another, "mini" load center with a small subset of circuit breakers. In these cases, it is best to add an additional 5-Amp circuit breaker and then run an outlet off of that subpanel. Plug the Envoy into that outlet, so that it can be close to the PV circuit breaker(s).

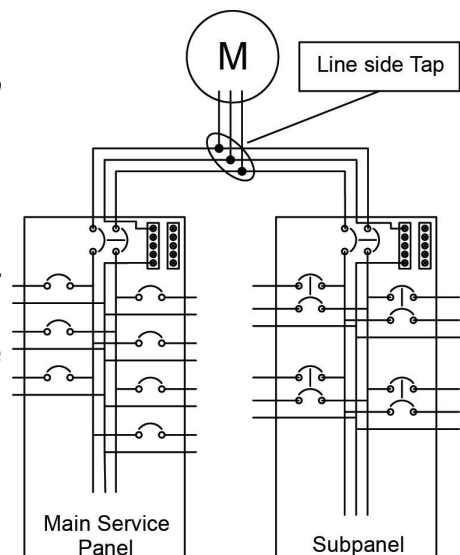
To facilitate power line communications with a line-side tap, you may need to install the Envoy on an outlet off the PV subpanel where you land the circuit breakers, prior to the utility tie-in. Try plugging the Envoy in near the electrical service center, as this may suffice.

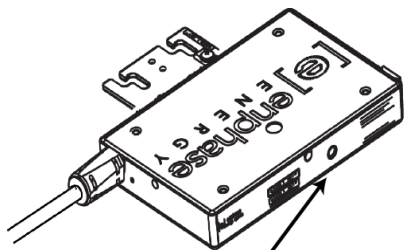
LED on long edge  
of M190 and M210

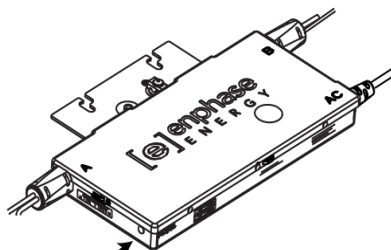
LED on short  
edge of D380

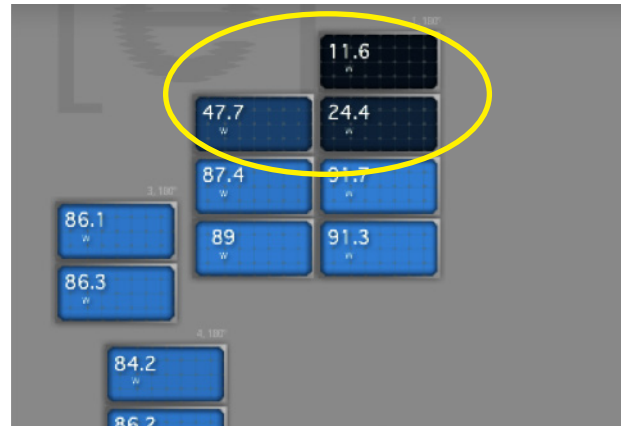
The 7-day time-lapse playback will give you a good idea whether a non-productive, or under producing PV/inverter pair shows repetitive production patterns that may be indicative of shading. The following Enlighten snapshot shows an example of a system with shading impacts.

If the periods of low production are fairly consistent and happen at the same time of day, shading is likely the cause.

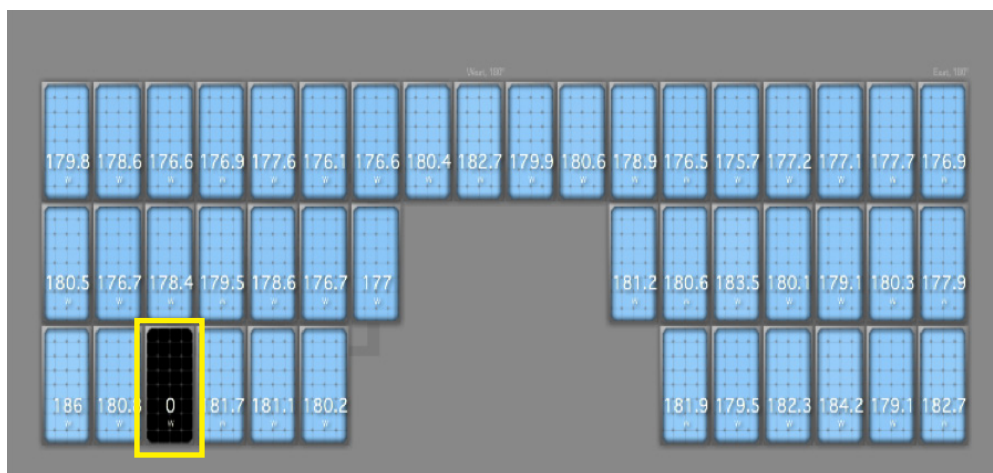
### Why is one unit showing 0W production when adjacent units are productive?

This means the inverter is communicating, but not producing. A unit that is communicating, but not productive, may be experiencing a DC side failure.

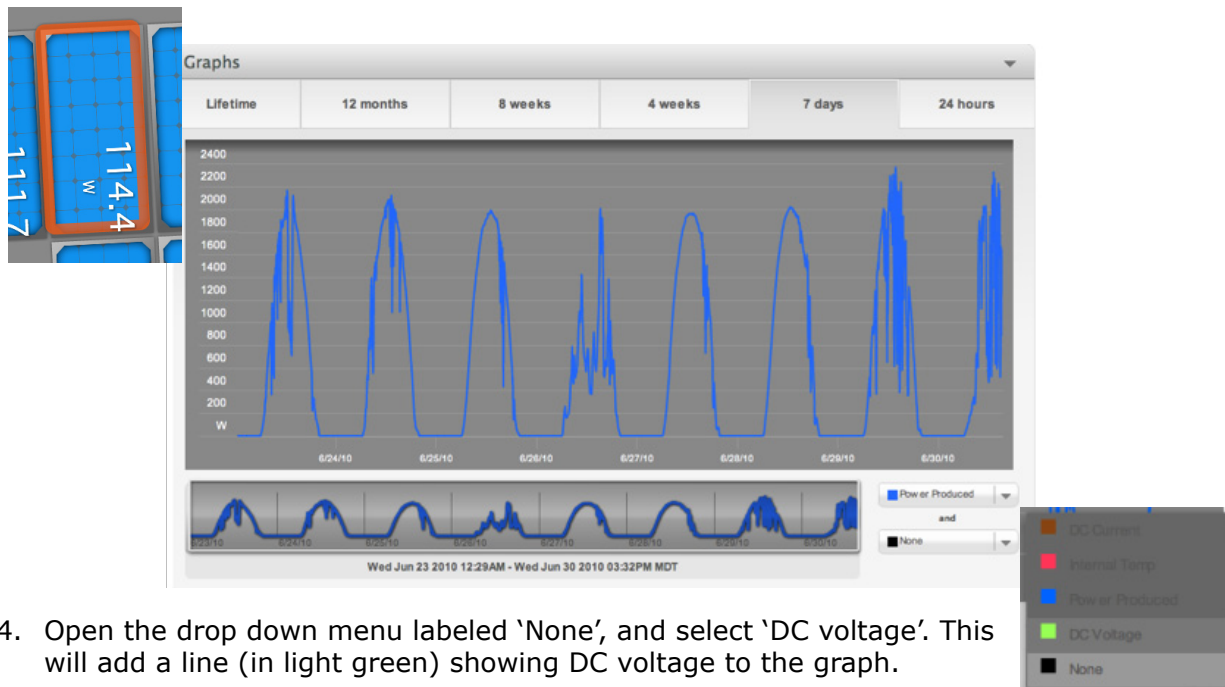
You can use Enlighten to gain a more detailed analysis of the problem. The DC measurements taken by the microinverter and viewable in Enlighten are key to identifying root cause of the problem. To view the DC measurements,

1. Click on the module under review in the Overview pane. The module will be highlighted (outlined with an orange box) after a few seconds.
2. Scroll down to the graphing pane.
3. Click on 7 days. The default view of the 7-day graph shows a production line in blue.

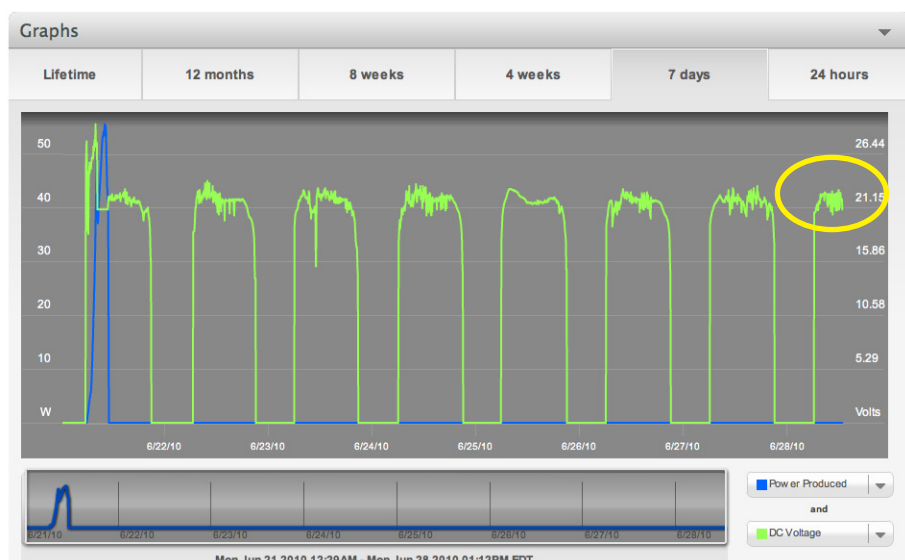
4. Open the drop down menu labeled 'None', and select 'DC voltage'. This will add a line (in light green) showing DC voltage to the graph.

In the following screen example, the microinverter under review reported production on 6/21/10, but did not report production after that. *This module reaches DC voltage of only ~21V after 6/21/10. The measured DC voltage after 6/21/10 was too low to power on the microinverter for energy harvest. It does not meet the required voltage to start up the microinverter.*

*Start up voltage requirements are:*

- The M190 and D380 models require DC voltage of at least **28V** to start up the inverter.
- The M210 model requires DC voltage of at least **38V**.
- The M215 model requires DC voltage of at least **26V**.

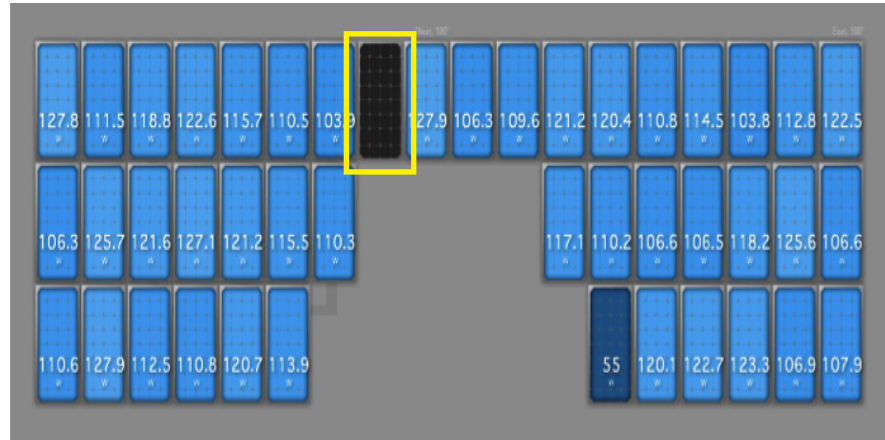
Modules that are shaded gray, with no indication of production level, have temporarily lost connectivity with the Envoy. This is different than a unit that is reporting, but reporting 0W AC power.

Communication outages may be caused by poor power line communications, or they may be caused by DC voltage that has slipped below the level required to turn on the inverter. Inverters that are not powered on will not communicate with the Envoy.
